NOAA, NATIONAL WEATHER SERVICE, WEATHER FORECAST OFFICE

...Detailed Summary of Oakland Park Tornado: March 29th, 2010...

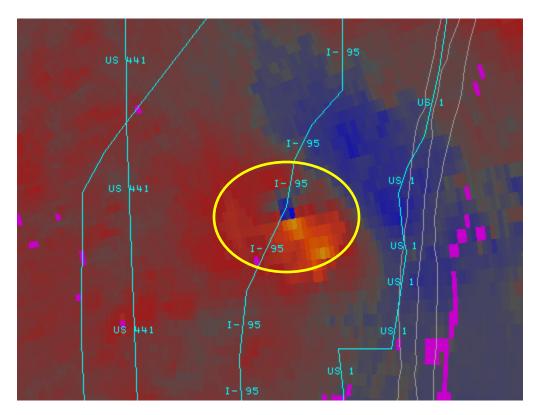
Figure 1: Rotation observed by TFLL Doppler Radar at 827 AM. Blue and yellow side-to-side squares inside yellow circle in center of image indicates cyclonic rotation associated with the supercell thunderstorm as it crossed I-95.

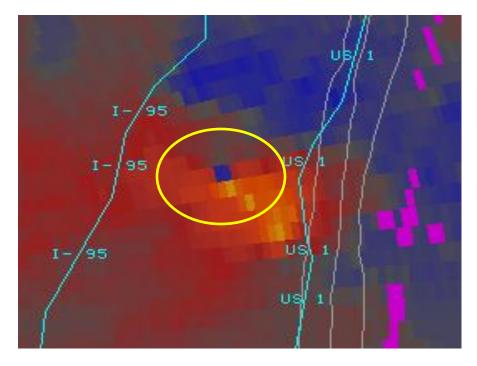
Figure 2: TFLL Doppler Radar image at 830 AM. Rotation now between I-95 and US 1 in Oakland Park.

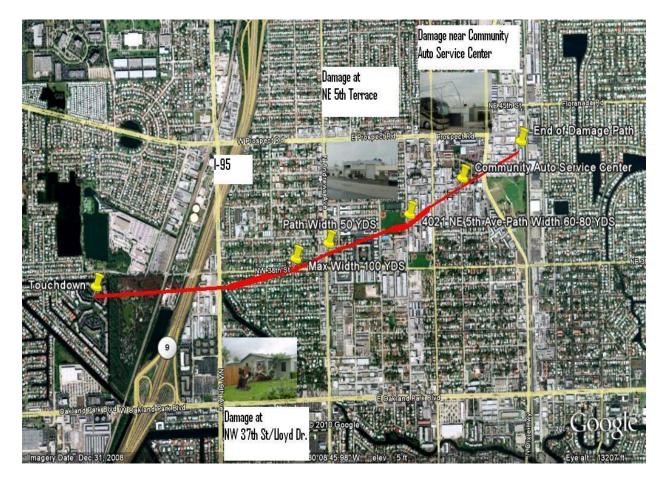
Figure 3: Path of tornado as depicted by the red line. NOTE: Damage occurred on either side of the path, not only along the depicted path.

Max winds estimated near 80 mph, greatest damage along NW 38th St between Powerline and Andrews and along NE 5th Ave and NE 5th Terrace between NE 40th and NE 42nd.

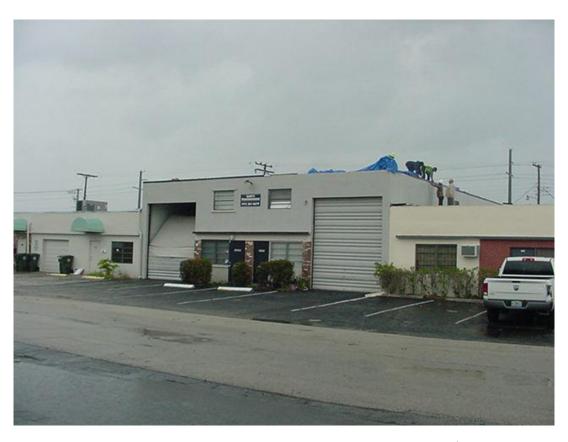
Picture 1: roof and garage door damage to warehouse on NE 5th Terrace

- Next N-S street east is NE 5th Terrace, several warehouses/businesses damaged here with two somewhat flimsy garage doors blown in, awnings damaged, roof extensively damaged at 4062 NE 5th Terrace, trailer blown sideways into a truck, two people behind garage door say they were blown backwards when garage door was damaged (Picture 1)

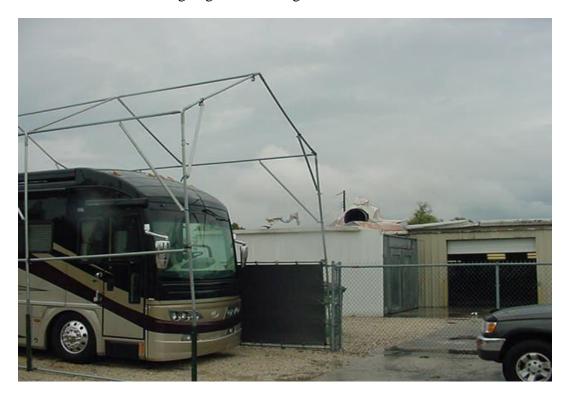
Picture 2: camper canopy blown off

- Just ENE from NE 5th Terrace is NE 42nd St, canopy over a large camper was blown away and into power lines at Community Auto Service Center, 801 NE 42nd St, but camper was undamaged. Some tree damage behind center. Lat 26.17845 Lon 80.13672 (Picture 2)

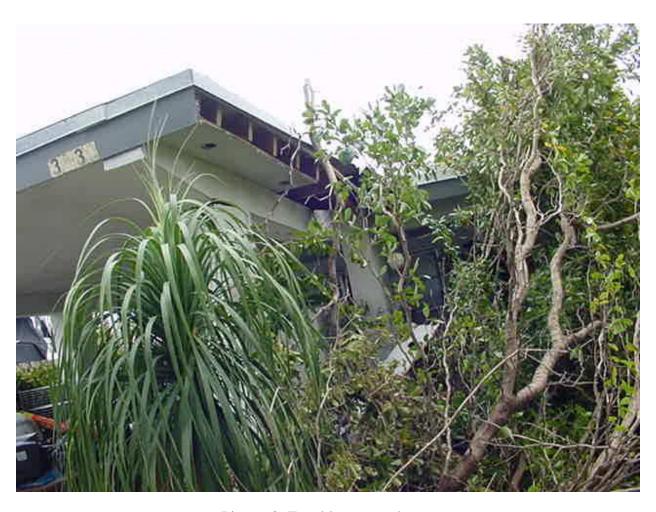
Picture 3: Tree blown onto house

- Large tree down on house, lying southwest to northeast, at corner of NW 37th Street and Lloyd Dr (843 NW 37th St), tree branch broke a window and crushed a fence, back fence blown down.
